BEARING FAILURE ANALYSIS

Example Type B Report

Wind Turbine Blade Pitch Bearing Analysis

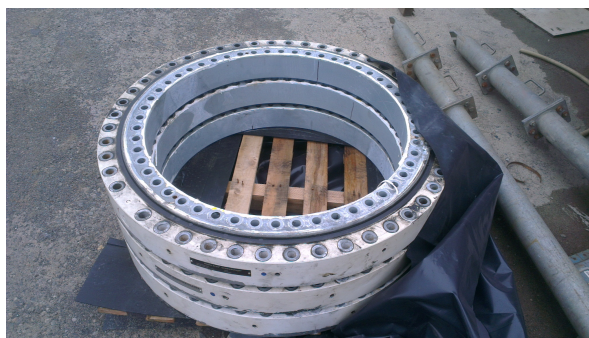
Figure 2

The ball bearing weighing approximately 500 kg each arrived stacked on a pallet (see figure 2).

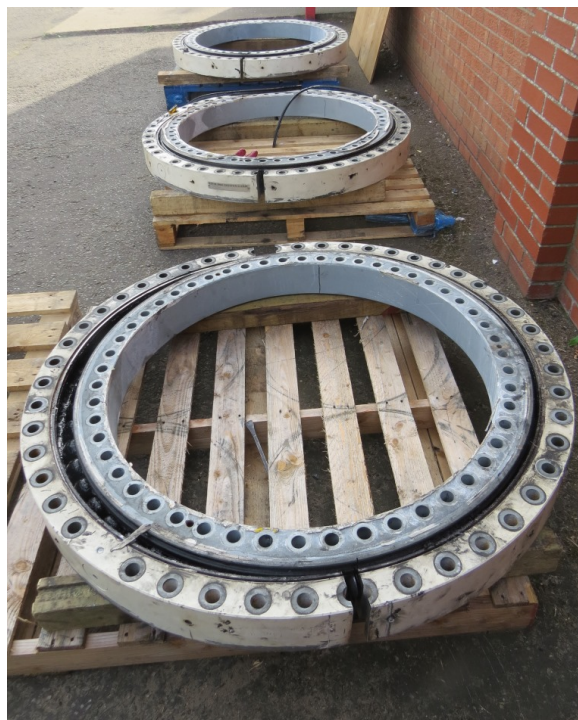
Figure 3

In order that a full and thorough examination of the rolling elements, lubricating grease and four-point contact raceways could be made it was necessary to cut the outer rings at two points. See figure 3.

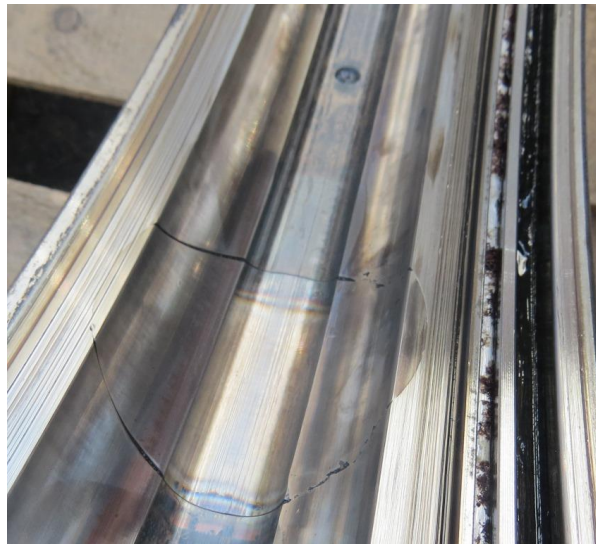
Figure 4

In all three bearings very light damage was identified around the location in the outer ring of the filling hole see figure 4.

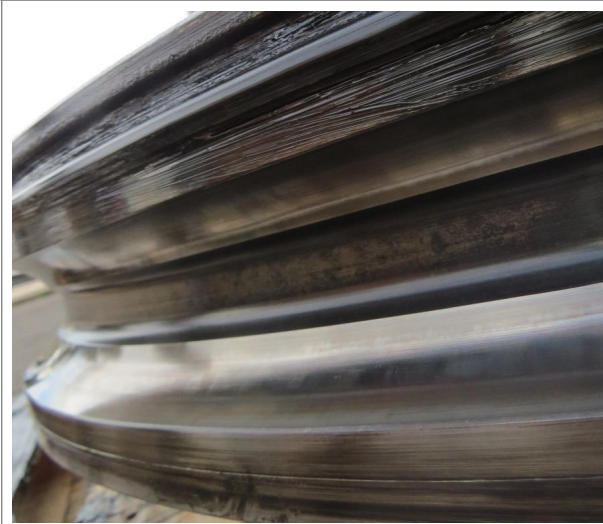
Figure 5

Results from in service grease analysis results, taken by the turbine operator, suggested that the limited amounts of small sized metallic debris was present. In two of the bearings, the remainder of the inner and outer raceways along with the steel balls all appeared in a serviceable condition and that no imminent failure was likely.

A typical raceway is shown in figure 5 and a typical set of the steel balls is shown in figure 6.

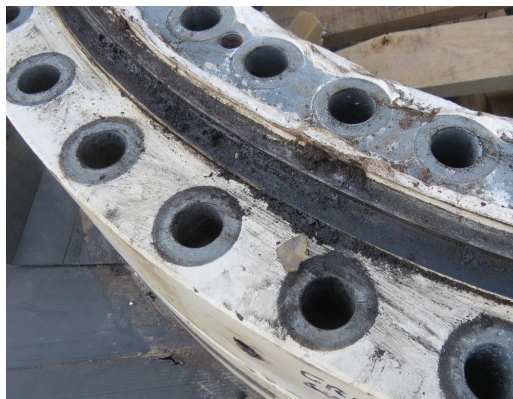
Fig 7

The final bearing in the set of three was seen to have larger amounts of dry and dirty grit and lubricant around the seals. See figure 7.

The in service grease analysis for this bearing suggested that there would be less fatiguing damage found on the raceways as the wear metal results were dramatically less than that for the previous two bearings.

The investigation was able to demonstrate to the turbine operator that revised grease sampling techniques were required to identify critically damaged bearings. The investigation also suggested that a review of the bearing sealing should be undertaken to prevent or at least reduce the ingress of other external harmful particles such as sand or salt.

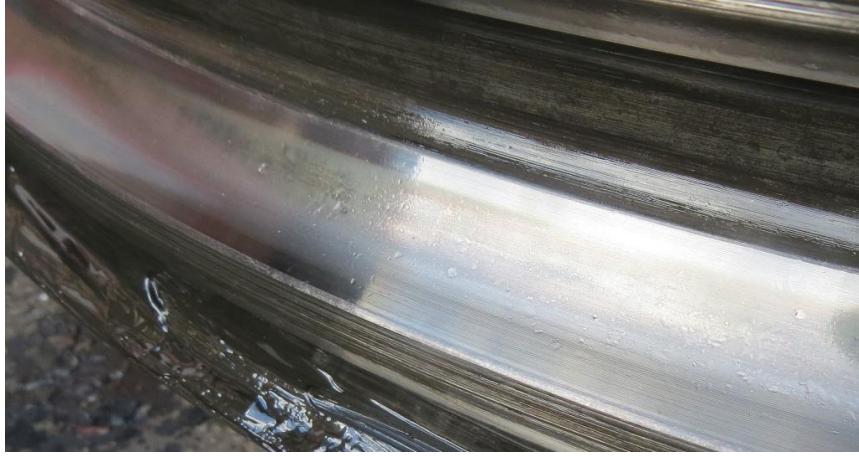
Figure 8

After cleaning both the outer and inner ring were seen to have large contact areas that had been affected by a phenomenon known as pear skinning. This is where large pieces of metallic debris become crushed onto the load-bearing surfaces by the rotating action of the bearing. See figure 8.

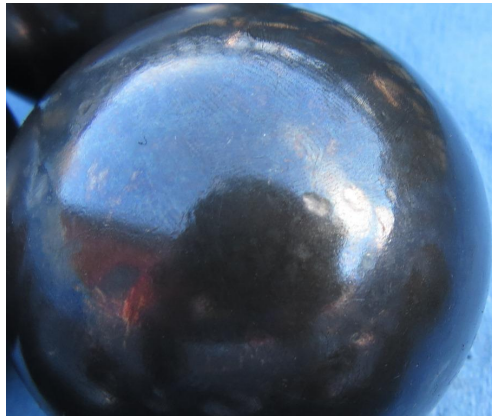
Figure 9

The steel balls from this bearing were also deeply discoloured and pear skinned. See figure 9.

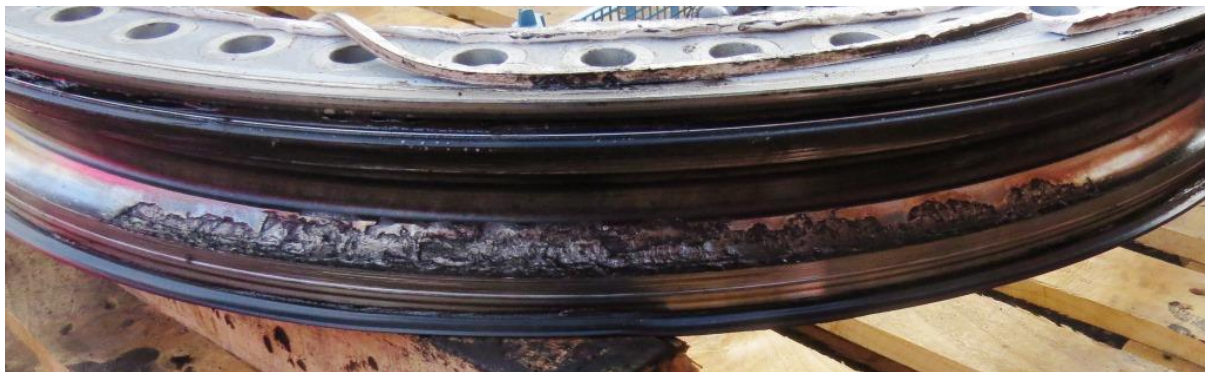
Fig 4

A full review of the inner ring identified a large area of fatiguing, see figure 10.

This large area of fatigue damage was clearly the source of the metallic debris that had caused the pear skinning. The fact that in service grease analysis has not detected the extent of the damage was investigated further.

Investigation identified that fatiguing and flaking existed within all bearings from this turbine, the most damaged of three, as well as having both large and small particles of metal within the grease had critical amounts of silicon also.
