BEARING FAILURE ANALYSIS

## Example Type B Report

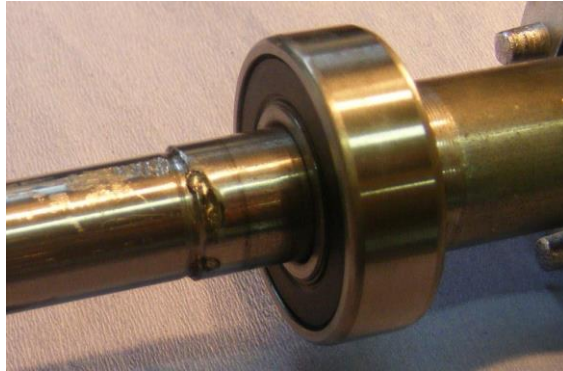
Fig 2 shows the bearing as held on the long shaft. As can be seen, there is heavy bruising and damage on the shaft, it is not clear if this damage was caused during disassembly or present during service. Such damage could manifest itself in terms of out of balance running and vibration if it was present during service.

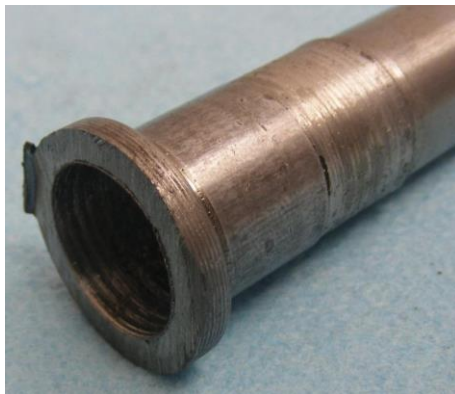
In order that the bearing could be removed without further damaging the raceways, the shaft was slightly relieved outboard of the bearing, cut 2mm from the inboard side and the centre of the shaft drilled out so that the interference between the bearing and the shaft could be relieved. See Fig 3.

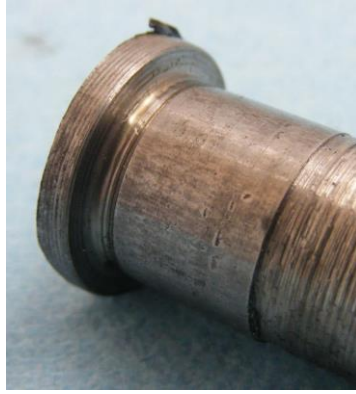
Fig 4 shows the journal surface and the condition of the abutment surface. Both were considered normal with no fretting or rotation evident.

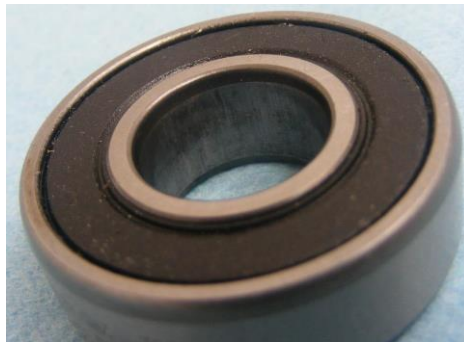
Fig 5 shows the removed bearing. Again no evidence of bore rotation or unusual fitting was noted.
