BEARING FAILURE ANALYSIS

Example Type B Report

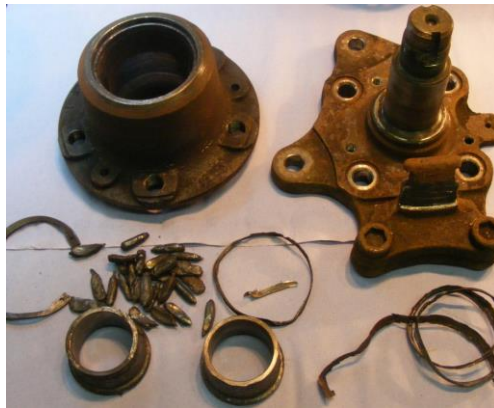
A wheel bearing was supplied to us for inspection and report, a double row tapered roller hub unit. See Fig 1.

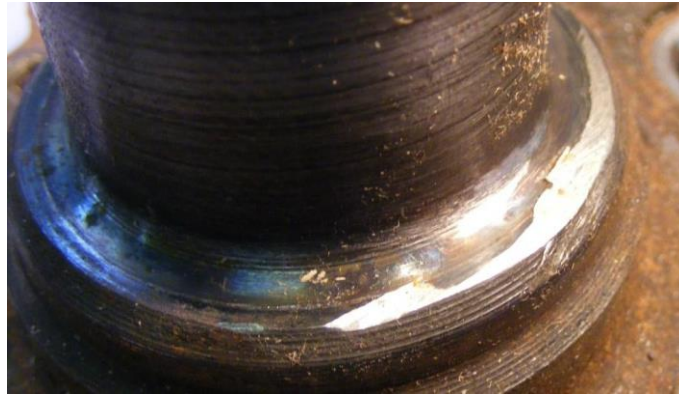
On close examination of other sections of this shoulder (9 o'clock to 6 o'clock) heavy burrs and deep circumferential markings could be seen. These marks were discoloured through heat tempering to a deep blue. This discoloration over the wear marks clearly suggested that the markings and damage had been present for some time prior to this failure occurring.

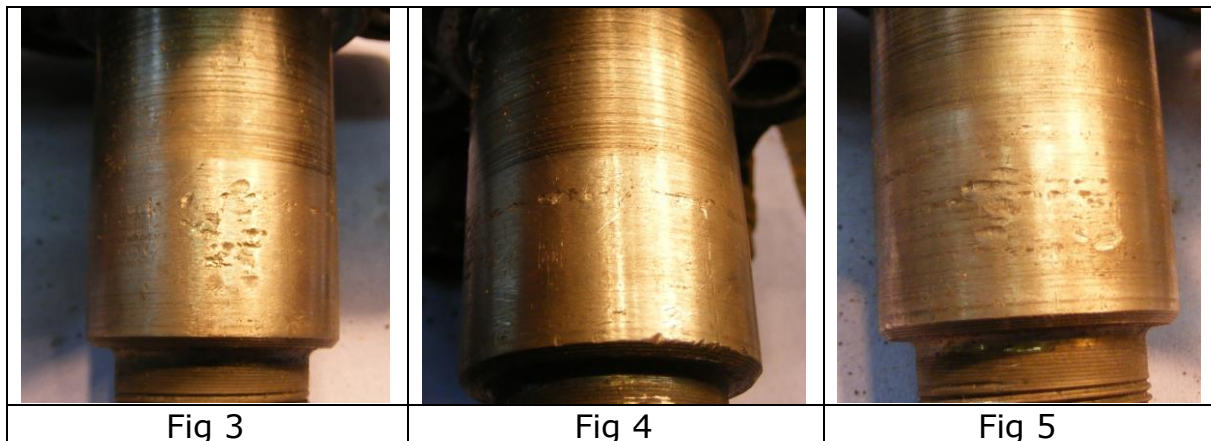
The edges of the pitting marks and indentations in the surface of the shaft showed evidence of smoothing and edge distortions, most clearly demonstrated in Fig 5. This is classical evidence of the shaft having been damaged as a result of an earlier bearing failure and a further set of bearings fitted over the areas of damage.

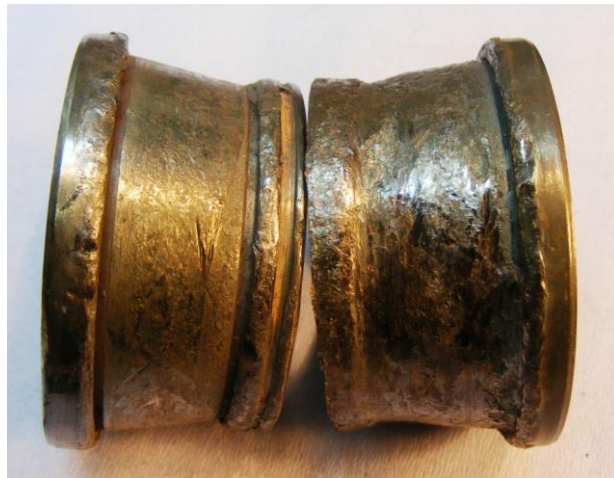
The ring to the right of the figure has slightly more distortion and is discoloured more through overheating. This suggests that the inner ring was subject to more loading in service than the other raceway from the pair.

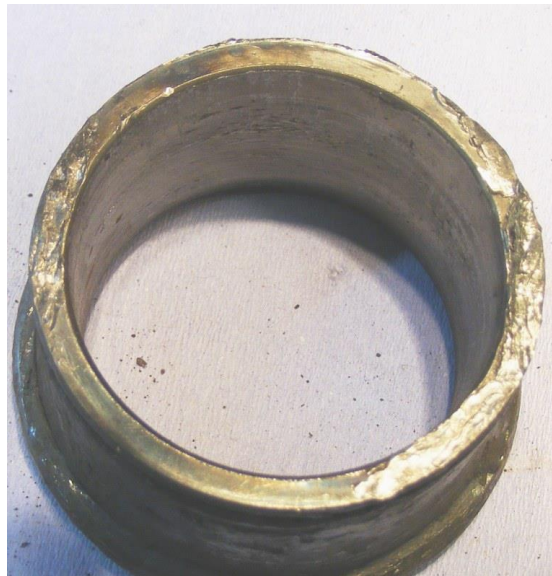
Fig 9 shows the nose of the same inner ring. As can be seen there is much evidence of impact damage and heat tarnishing. The impact damage appears to have been caused during bearing removal from the shaft. Areas without indenting show heat tarnishing, burrs and evidence of inconsistent contact. These marks suggest that the nose of the ring has not been in firm contact with the other ring in the pair.

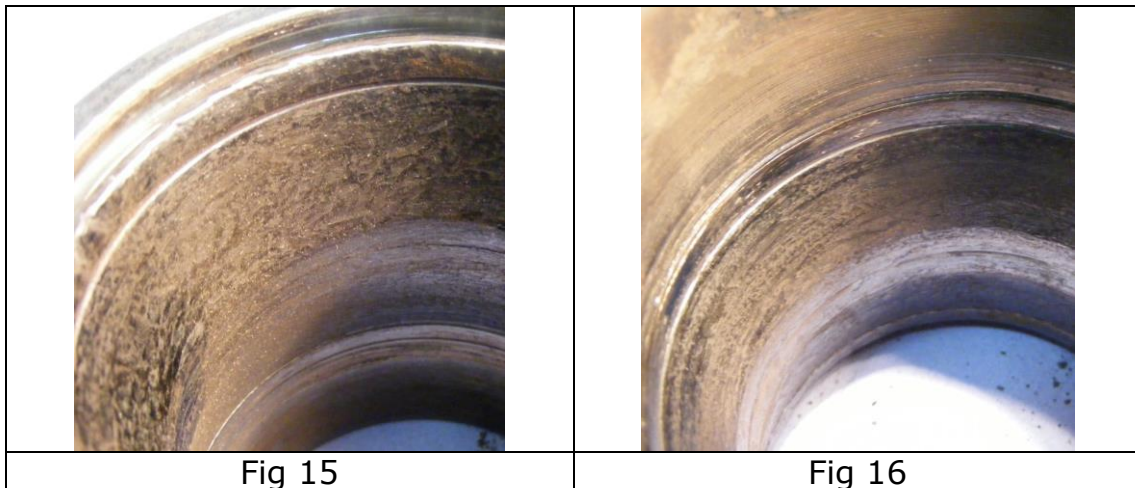
3 DISCUSSIONS AND CONCLUSIONS
