BEARING FAILURE ANALYSIS

**Example Type B Report**

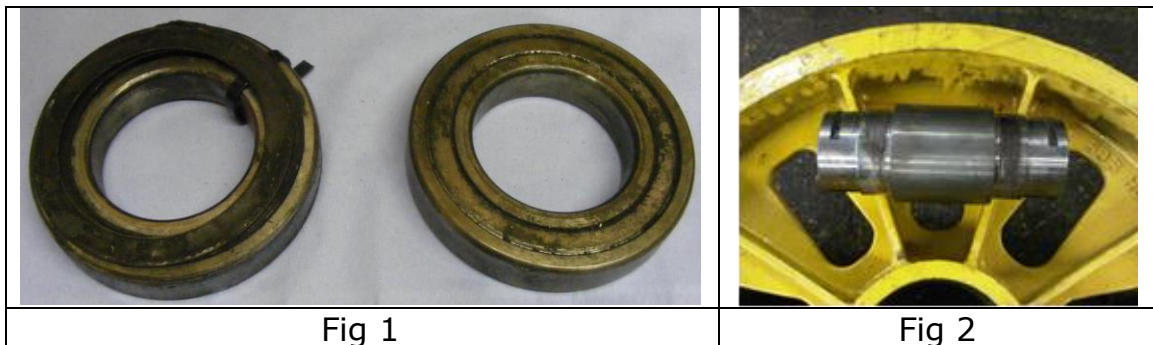
One of the bearings was in an assembled condition; however, the other had a cracked inner raceway and two loose metal shields. All bearings were very dirty and had a coating of unidentified gummy residue. The gummy residue had a strong rubbery smell.

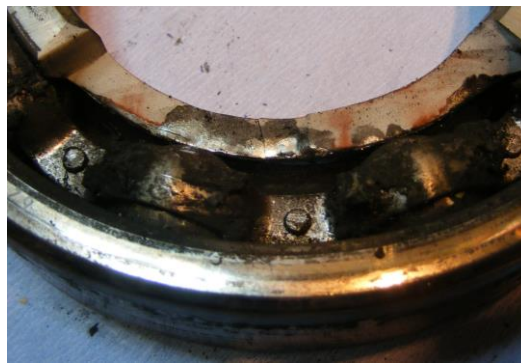
The cracked part of the ring was removed to reveal further cracks running fully through the ring, see Fig 7.

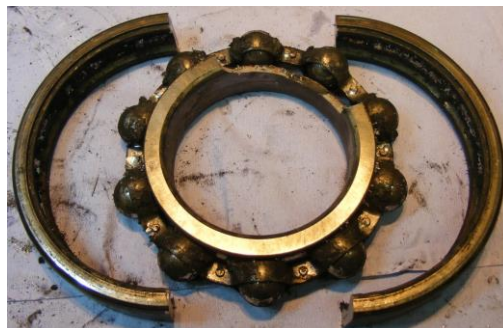
In order that the investigation could be furthered, it was necessary to disassemble the bearing. This was accomplished by cutting the outer ring in two places, see Fig 8

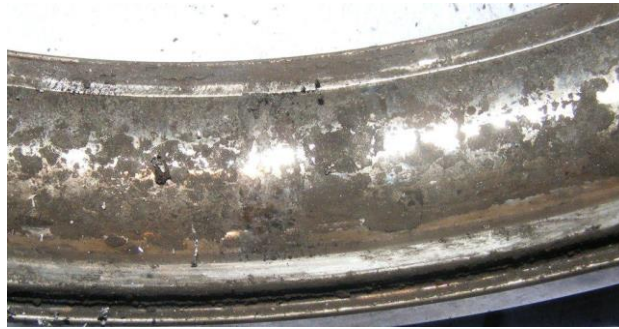
were washed in degreaser which still did not remove the entire residue. See Fig 9.

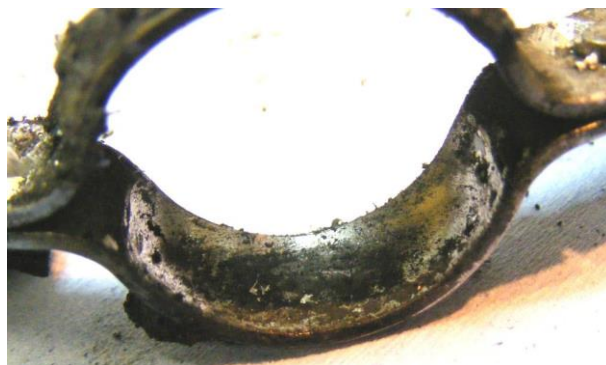
The pockets were inspected, see Fig 11, this clearly shows more gummy residue along with areas of wear and erosion.

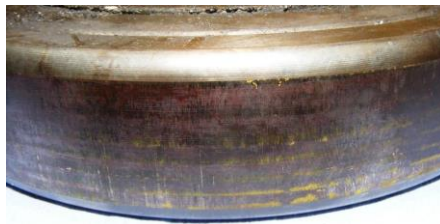
The bearing turned easily by hand but when visually inspected, the exterior surface of the outer ring showed some evidence of fretting. There was much less damage seen on this bearing than on bearing one. See Fig 14.

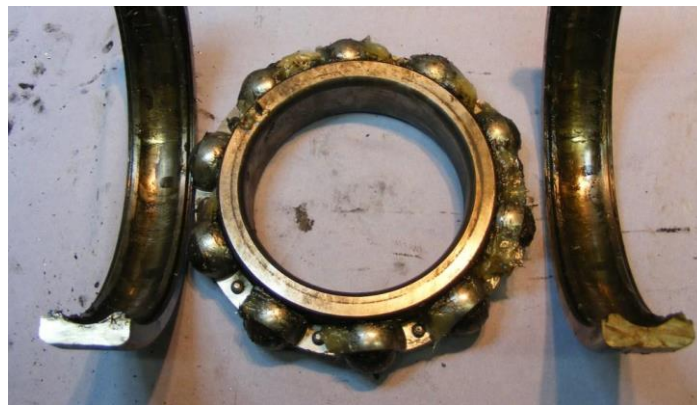
Once again the bearing was cut to facilitate further internal inspections. See Fig 17.

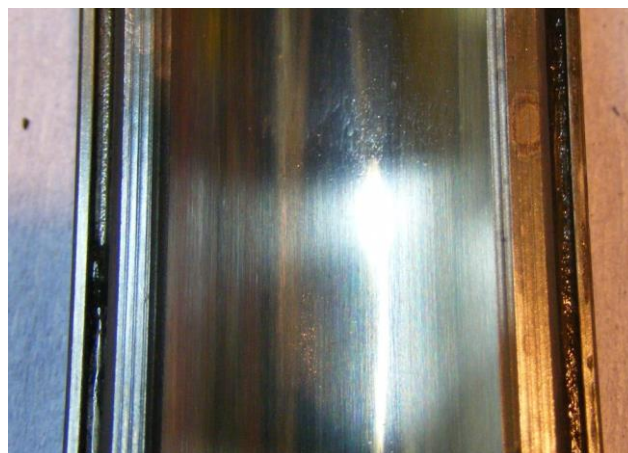
The ball bearings remained firmly within the cage pockets suggesting that there was little to no wear on the balls or inside the cage itself. The outer raceway wiped clean easily to reveal a generally normal surface. See Fig 18
