BEARING FAILURE ANALYSIS

Example Type B Report

Wind Turbine Blade Pitch Bearing Analysis

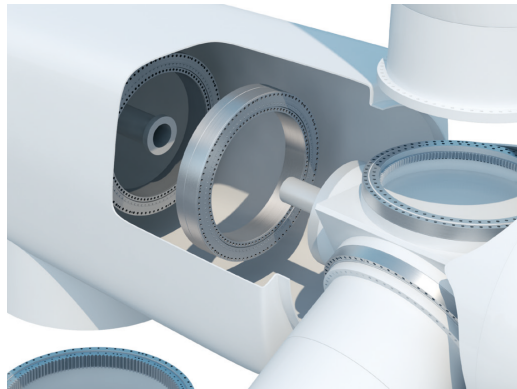
Figure 1

Three wind turbine Rotor Pitch Blade bearings that had been in service for approximately 10 ½ years were supplied to us for inspection and report. The rotor pitch bearings are the right hand side of figure 1.

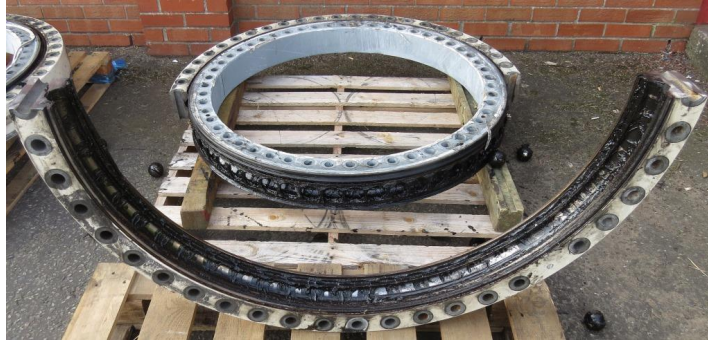
Figure 3

The components of all three bearings were carefully separated in order that cleaning and detailed inspections could be carried out. See figure 3
